# STRUCTURAL INSPECTION

For: SHIRE OF LAKE GRACE

Project Address: #15 STUBBS STREET LAKE GRACE

Job Number: S1205154

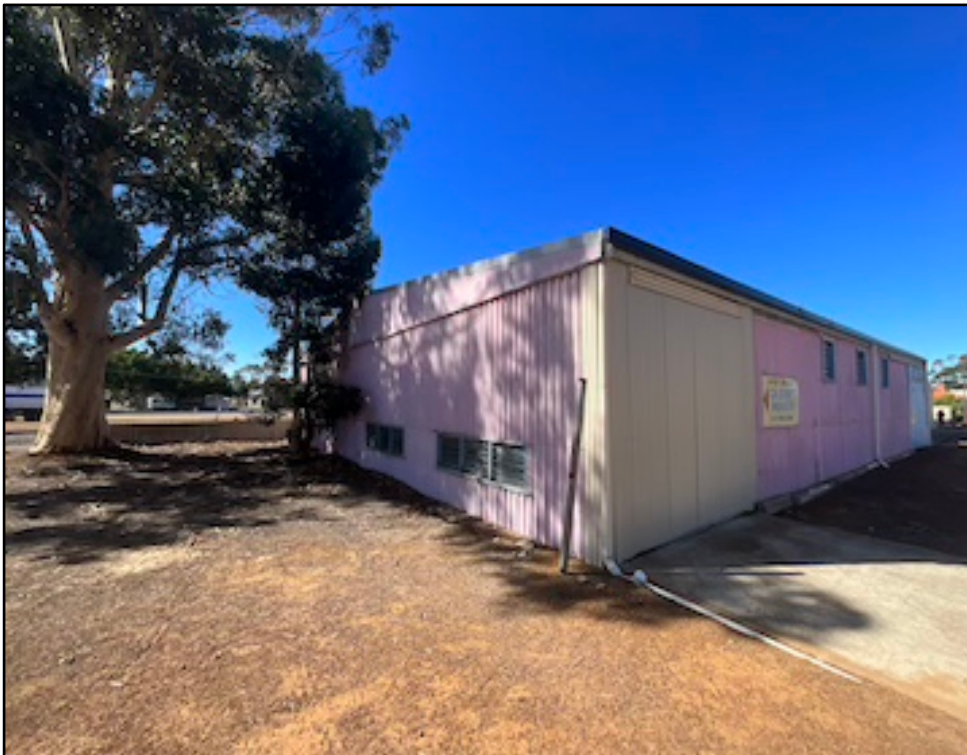
The structure is single storey. While the exact age of the structure is unknown, by observations of the members and style of construction it is estimated to be more than 50 years old. Photograph 1 shows the structure inspected. The following materials and constructions styles were observed:

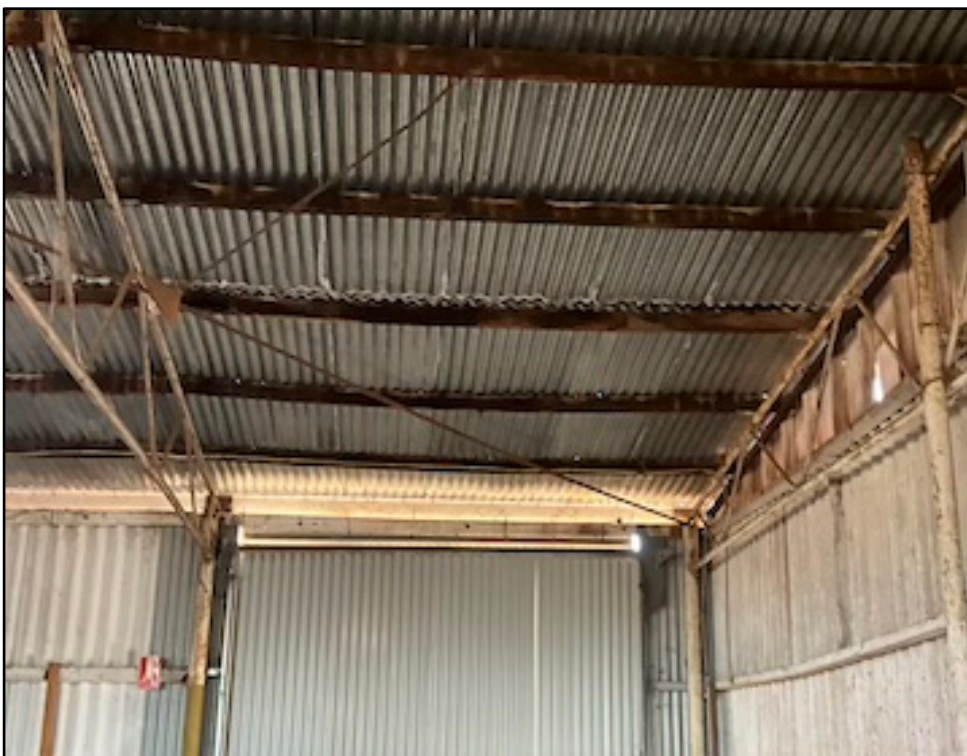
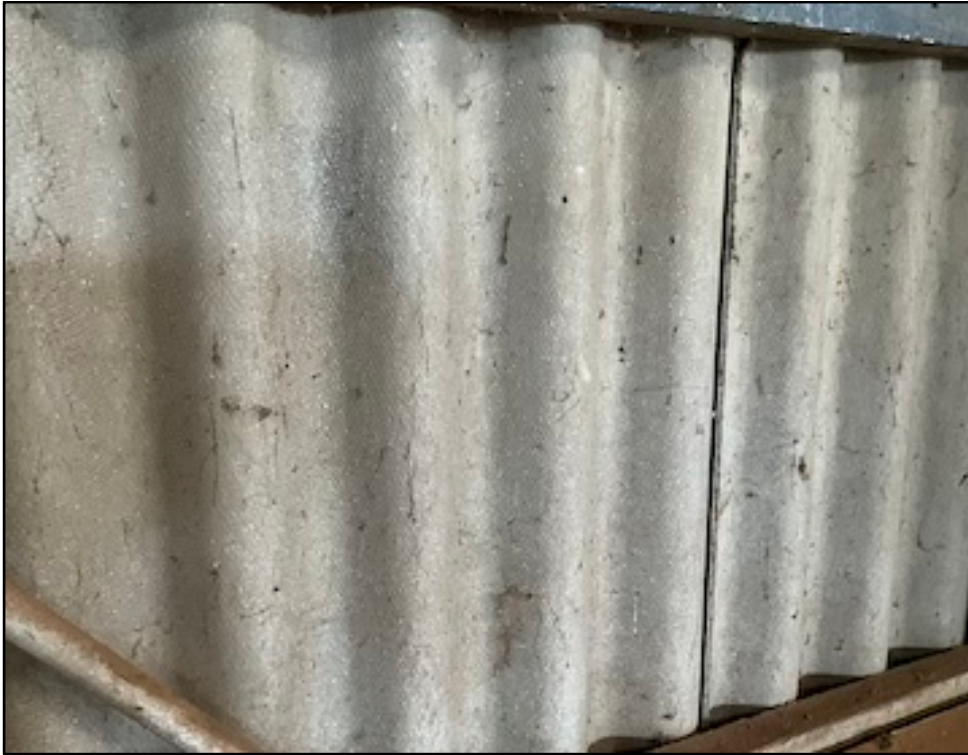
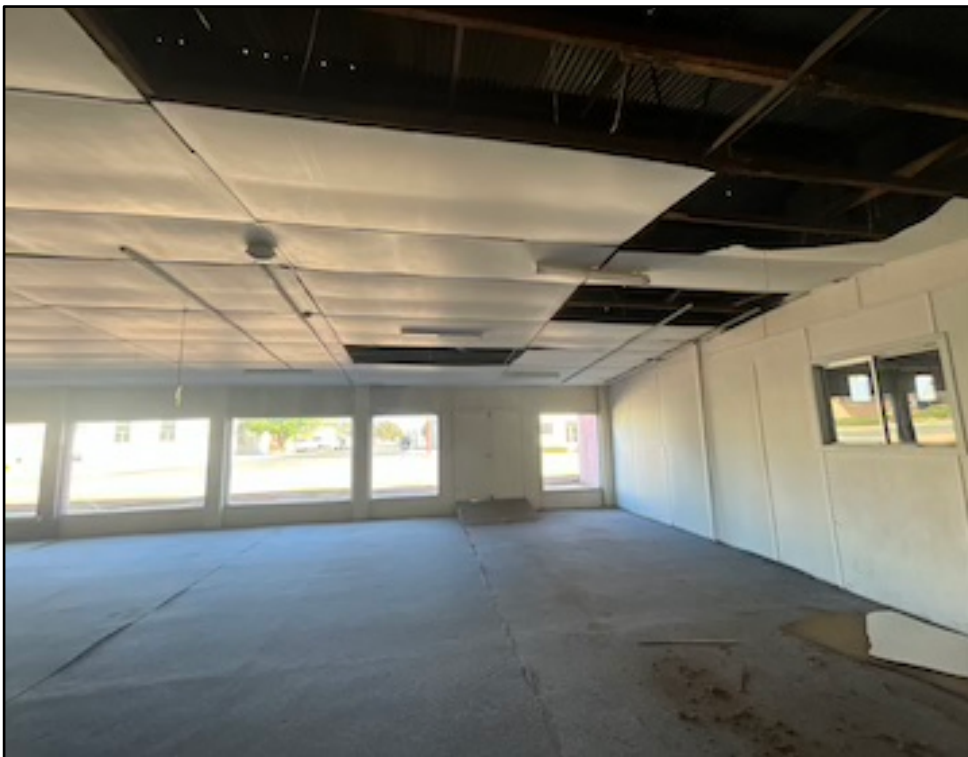
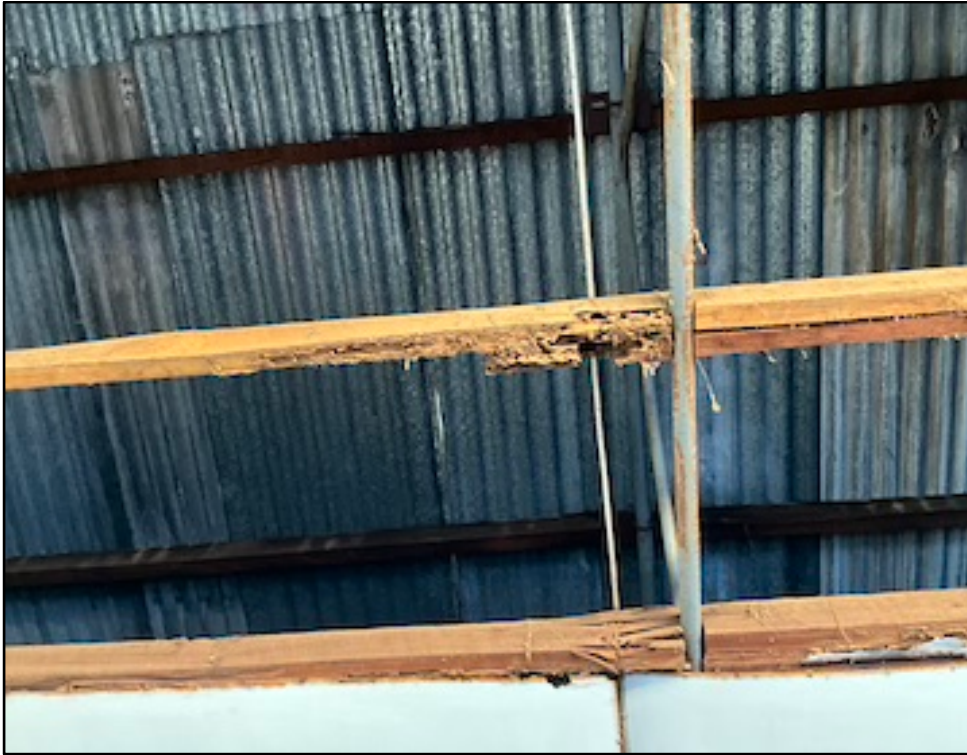
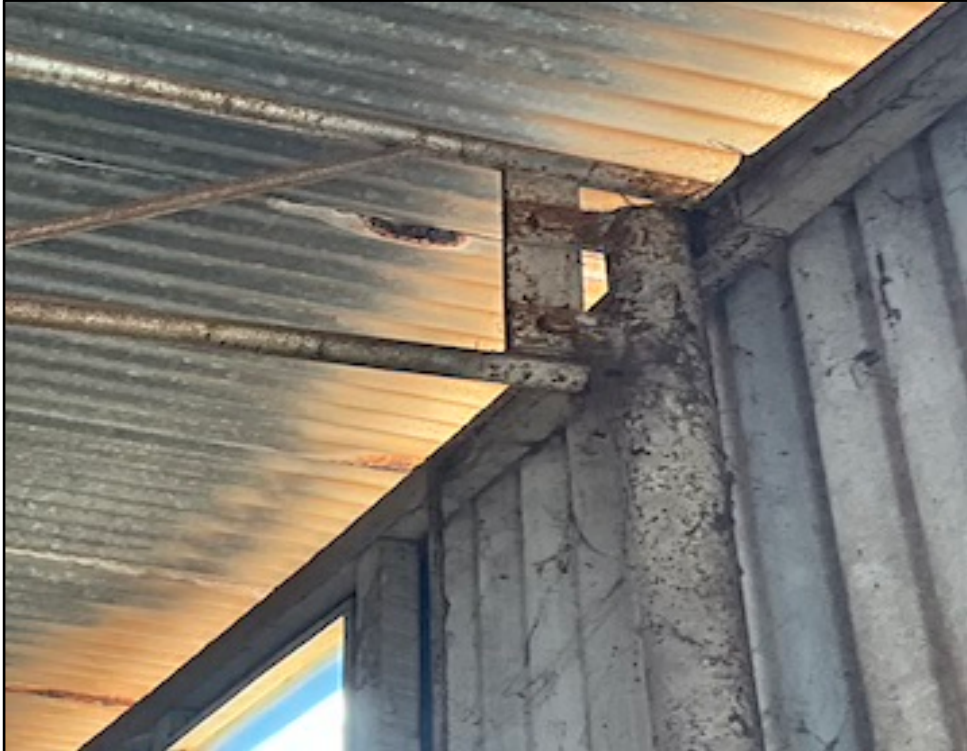
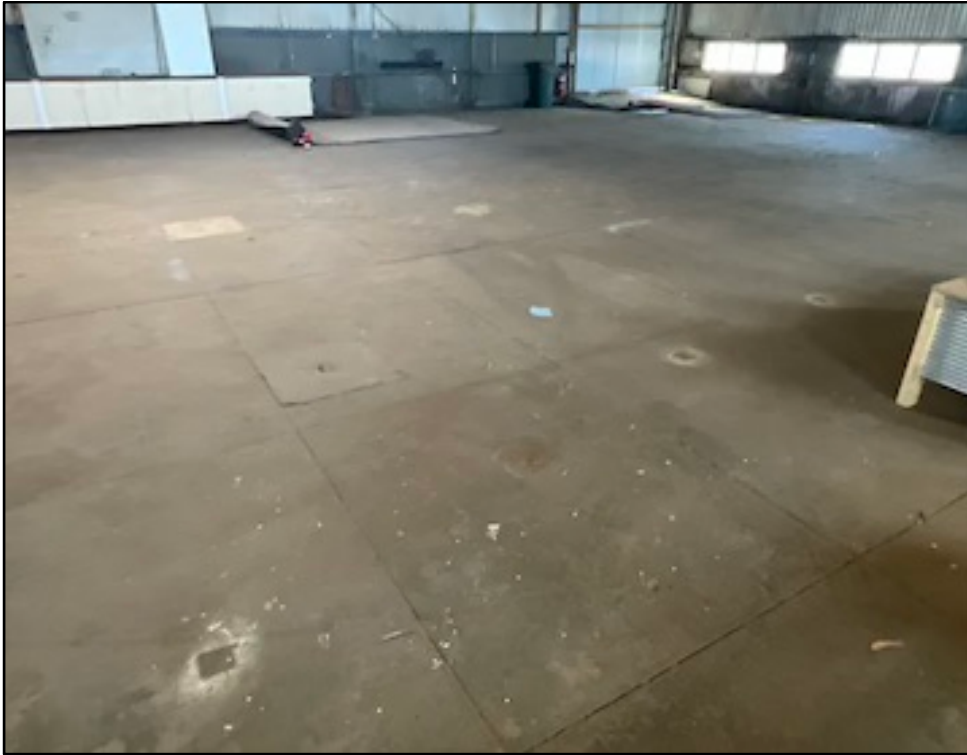
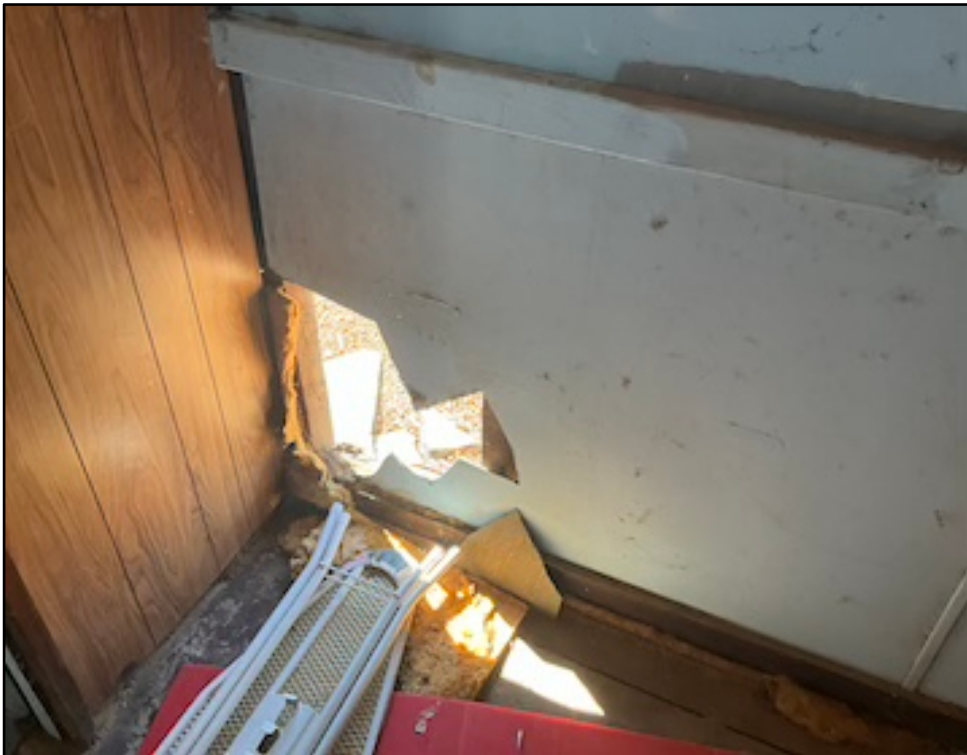
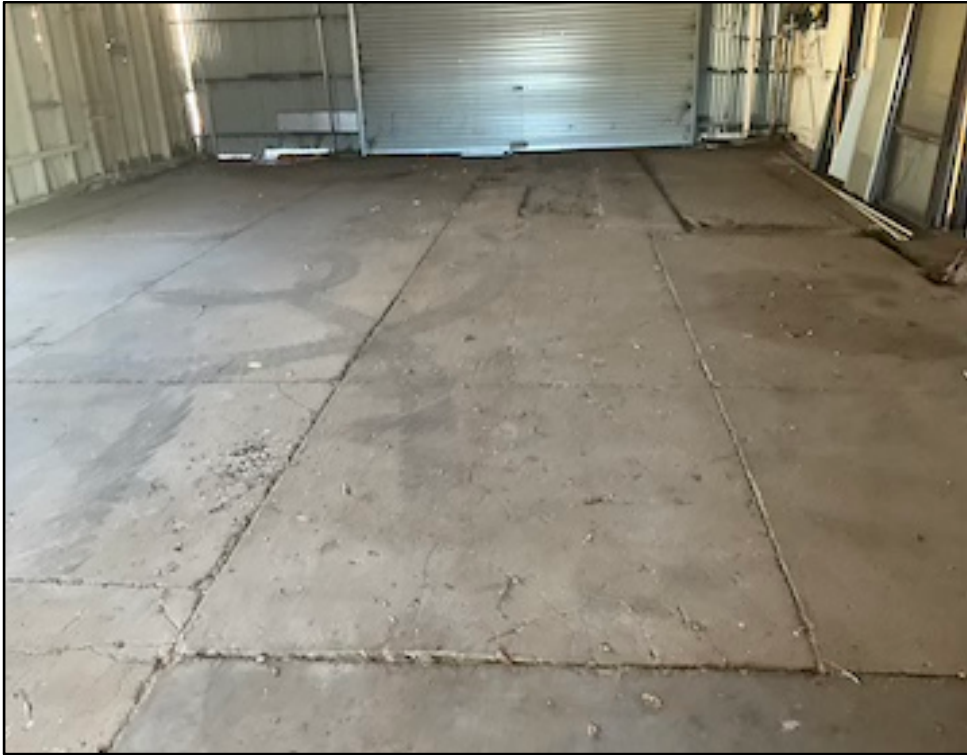
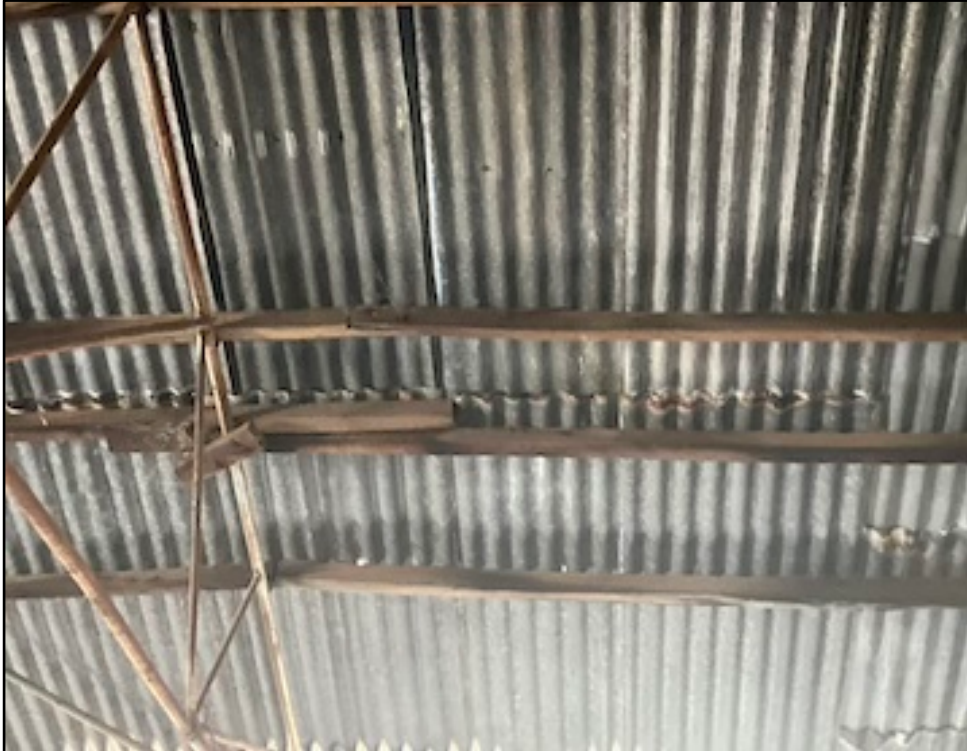
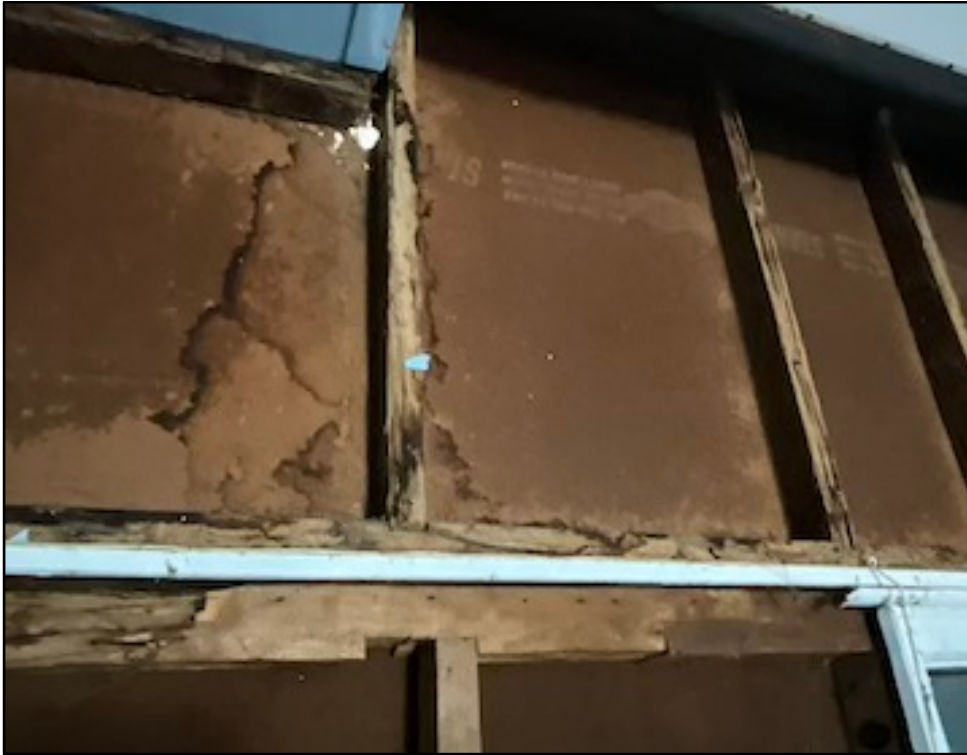
The metal roof cladding is rusted throughout, and the steel frames and connections underneath show signs of corrosion.

Ceiling cladding was observed to be damaged and, in some locations, not present at all.

Concrete flooring shows signs of cracking and was noted to be uneven throughout. The concrete also shows signs of corrosion and deterioration due to build up of chemical products.

Termite activity was noted to majority of timber members.

Photographs 2 – 11 show the extent of the damage observed onsite.

- Upgrade and/or remove and replace existing truss portal frames with new members designed in accordance with current Australian Standards.
- Remove and replace wall girts and roof purlins
- Remove and replace roof sheeting. New sheeting to be fixed in accordance with current Australian Standards.
- Upgrade all timber framed walls in accordance with AS1684.2, provide bracing in accordance with current Australian Standards to withstand wind loading.
- Remove and replace all other termite affected timber not listed in the above.
- Remove and replace all asbestos products with a modern alternative.
- Treat corrosion to all other steel members not listed above.
- Provide sufficient stormwater management to all roof areas, including adequate gutters, downpipes and soakwells set back a sufficient distance from the structure.

Typically this Office recommends that all termite affected timber where more than 10% of the cross sectional area is reduced at any point is replaced like for like. A suitably qualified carpenter can assess each affected timber member as required once activity has been eliminated by a pest controller.

Typically this office recommends that any steel member that is reduced by more than 10% of the cross sectional area by corrosion is either removed and replaced or the section is adequately filled by a

suitably qualified tradesperson via welding techniques. Surface corrosion elsewhere is to be removed and a cold applied corrosion inhibitor provided to the entirety of the steel members.
